## GEOENVIRONMENTAL CHARACTERIZATION OF AN ATLANTIC FOREST SLOPE IN SÃO SEBASTIÃO (SP)

*The urban expansion and the growth of economic activities related to tourism, as well as those related to the port and sea, resulted in the occupation of the Serra do Mar slopes, in the municipality of São Sebastião - SP. This study was carried out in a clearing in an Atlantic Rainforest fragment of 4.8 hectares, located in the municipality of São Sebastião-SP, to provide subsidies to prevent and/or reduce the risks of land slippage on the slope. Thus, this work analyzed, characterized, and described the physiography and the properties of the soils on a slope of an Atlantic rainforest in the municipality of São Sebastião – SP, aiming to obtain a product on the risk of urban occupation. That is why, we used indicators associated with landscape physiography as a feature of slope (slope declivity), anthropic features (deforestation for crop cultivation and cattle raising) and soils (texture and pedogeochimistry). The results recommend structural actions, allowing the implementation of preventive measures such as revegetation of the area, thus minimizing the risks of land slippage and evolution of

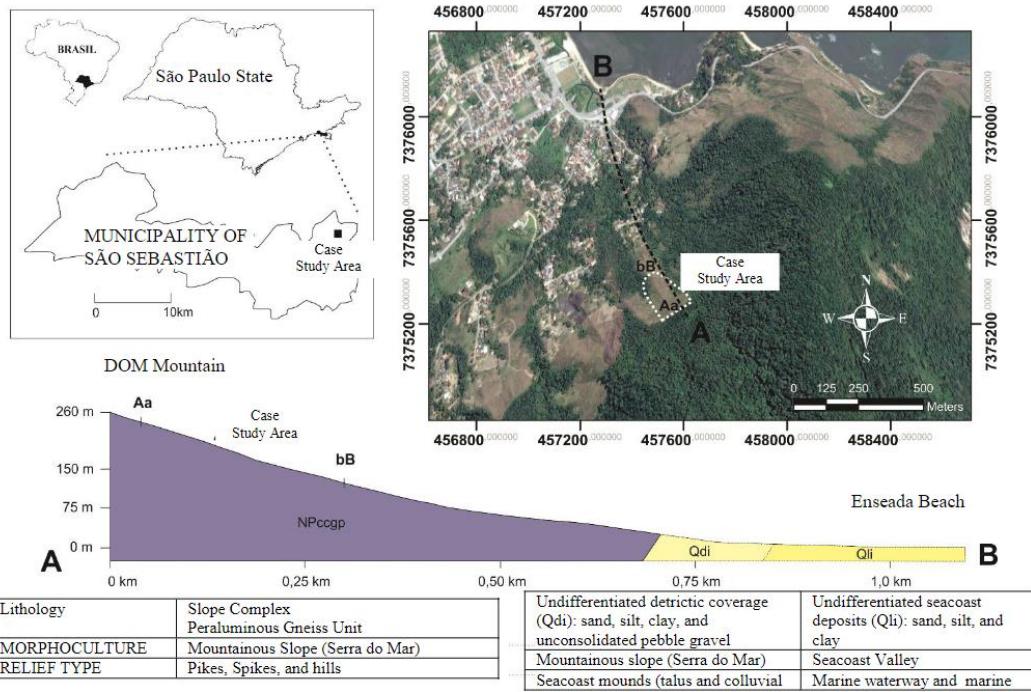
**Figure 1.** Location of the (A-B) region and the (Aa-bB) case study area, lithology, morpho culture, and types of topological reliefs.

The case study area is in the municipality of São Sebastião, and it is situated in the southeastern part of São Paulo State, along the northern seacoast. It occupies approximately 410 km<sup>2</sup>, around 70% is in the Serra do Mar State Park. It is bordered on the north by the municipality of Caraguatatuba, on the northwest by Salesópolis and the west by Bertioga (Garcia, 2005) [6]. It is lapped by the Atlantic Ocean along its southern sector and the northwest and the east by the São Sebastião Channel (**Figures 1 and 2**).

The case study area is located near a 4.8 hectare fragment of the Atlantic Rainforest, precisely located from latitude 25° 25' 30" to 45° 25' 37" and from longitude 23° 44' 10" to 23° 44' 19", the levels range from 105 to 235 meters in altitude (**Figures 1 and 2**). The native vegetation was composed by the same vegetation as borders the boundaries of the fragment, classified as Dense Ombrophile Forest (Veloso *et al.*, 1991) [7]. Currently, the fragment is now covered by pastures; however, it is surrounded by native vegetation, along the lateral slopes as well as on the mountains, where it dominates even at the highest altitudes. Regarding the fauna in the region, there are several kinds of wild animals, such as feral pigs, "quatis," lizards, "pacas," and diverse birds.

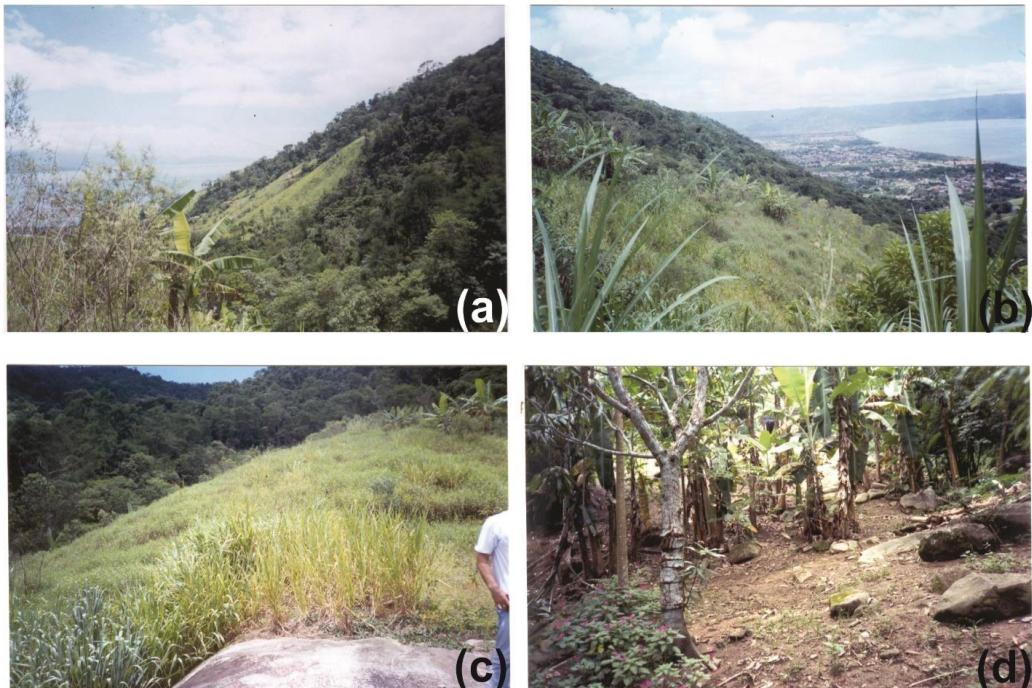
**Figure 2.** (a) Slope with a rectilinear profile and an angular summit located in the eastern part of the case study area. (b) Slope with a rectilinear profile and an angular summit located in the western part of the case study area. (c) The summit of the studied fragment with a convex shaped slope. (d) The base of the studied fragment with predominant talus deposits.

Regarding geomorphology, the case study area is on the northern slope of the Serra do Mar and, according to the geomorphologic map of São Paulo State (IPT, 1981) [9], showing cliffs with the formation of spikes, made up by large sub-parallel linear cliffs, angular summits, and rectilinear profile slopes (**Figures 2a and 2b**). Convex shapes are predominant on the stretch of the studied fragment, bordered by recessed valleys (**Figure 2c**). On lower altitudes, there is a talus body, which displays a large number of different sizes of surface and sub-surface blocks (**Figure 2d**). There is high-density drainage, a parallel-pinnacle pattern, and enclosed valleys.

Blocks and buried volcanic boulders are amidst modified coverage and they were noted during the course of the expedient mapping (**Figure 2a**). These blocks vary in size, as they are generally metric, and the largest is located in the central part of the area. They measure 4 x 5 meters (**Figure 2b**). There are gneiss rocks with migmatite structures (leucocratic grains

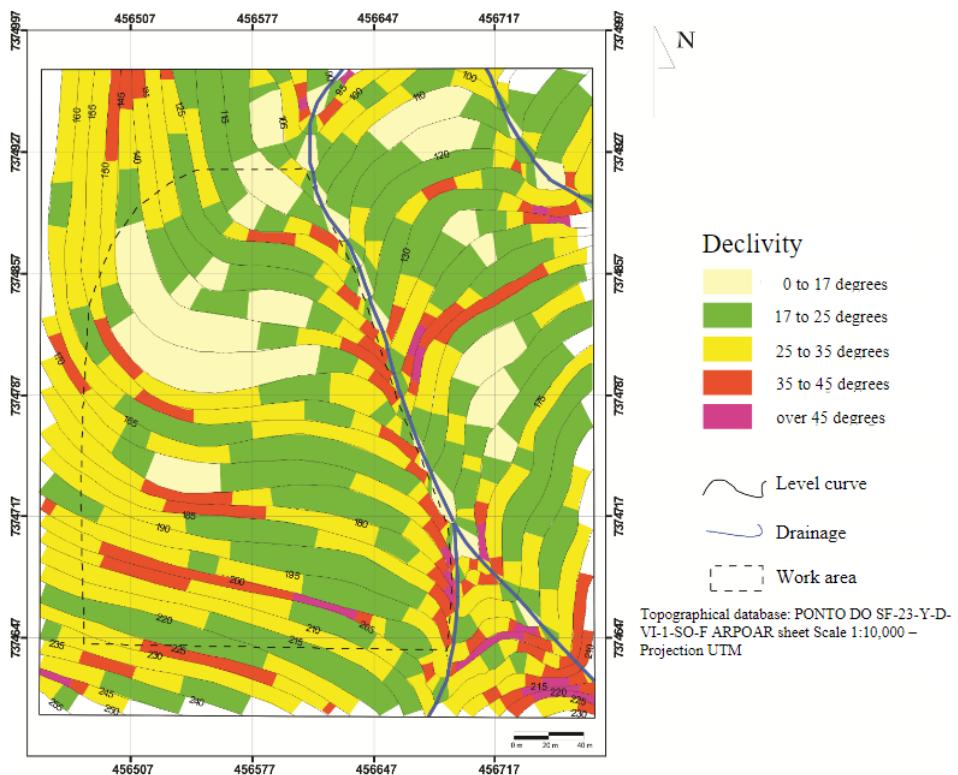
**Figure 3.** This declivity map shows the location of the case study area.

According to the information obtained from the declivity map (**Figure 3**) and the field observations, the numerical values are calculated on the morphometric attributes of the fragment being studied, which are grouped in **Table 1**. Based on those data, the topological relief shapes were classified according to the criteria of (Moreira and Pires Neto, 1998) [15] and they are listed in **Table 2**. The case study area abides by the classification as a high-susceptibility domain for surface soil erosion and a very high-susceptibility to land slippage (natural and induced). According to Tatizana *et al.* (1987) [16], the susceptibility of land slippages is extremely variable in each sector of the Serra do Mar, as a reflex from the geological, geomorphology, declivity, vegetation coverage, and rainfall regimes.

The change in the vegetation pattern of the fragment has accelerated due to the erosion process and the shifting of matters to thereby increase the increase of sediment and blocks in the downstream regions, where there are some houses and residential plots at the foothill of the slope. Regarding this, the presence of geological risks from slope slippages and the rolling of blocks, as declivity (Figures 2 and 3 and Tables 1 and 2) is an important parameter for evaluating geotechnical stability.

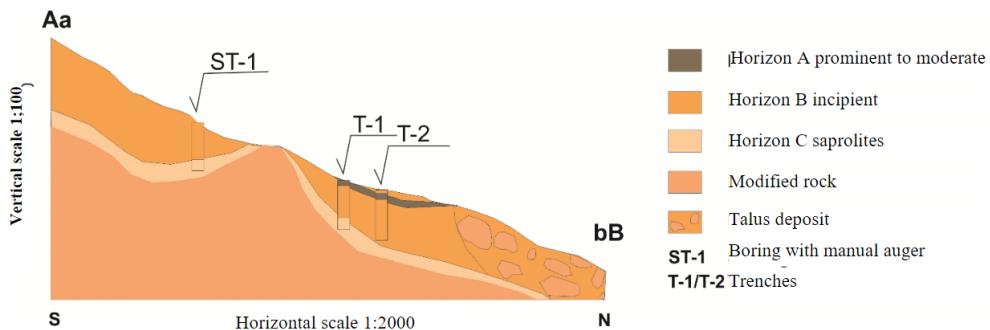
**Figure 4. The S-N profile of the case study area (Aa - bB) highlighting the pedological structures with boring points by using a manual auger (ST-1) and trenches (T-1 and T-2) for collecting soil samples.**

It was possible to observe and describe a The S-N profile of the case study area (Aa - bB) at the boring site perforated by the manual auger (ST-1).B Horizon with a 0.6 m thickness at the summit, a sandy-loamy texture mixed with quartz, micas (muscovite and biotite), a yellow and homogenous color, and predominant quartz and kaolinite, with the preservation of the rocky structural features (Figure 4).

In trench (T-1) at the summit measured at approximately 0.2 m into prominent Horizon A, it was dark colored, followed by Horizon B in the middle, ranging in thickness from 0.6 to 0.7 m and its texture is sandy-loamy with quartz, micas (muscovite and biotite), homogenous, and Horizon C is 1.5 m at its base, and its texture is sandy-loamy with quartz, micas (muscovite and biotite), and there are predominately quartz and biotite, with clustered fragments (saprolites). Since trench (T-2) measured at 0.2m Horizon B at the summit, as there is a sandy-loamy homogenous texture mixed with quartz and micas, ochre coloration, in the middle, there is buried mineral organ at Horizon A, 0.3 m, homogenous, dark brown color, medium thick granulation, and at the base there is a 1.5 m sandy-loamy texture of Horizon B that is a homogenous, light brown color (**Figure 4**).

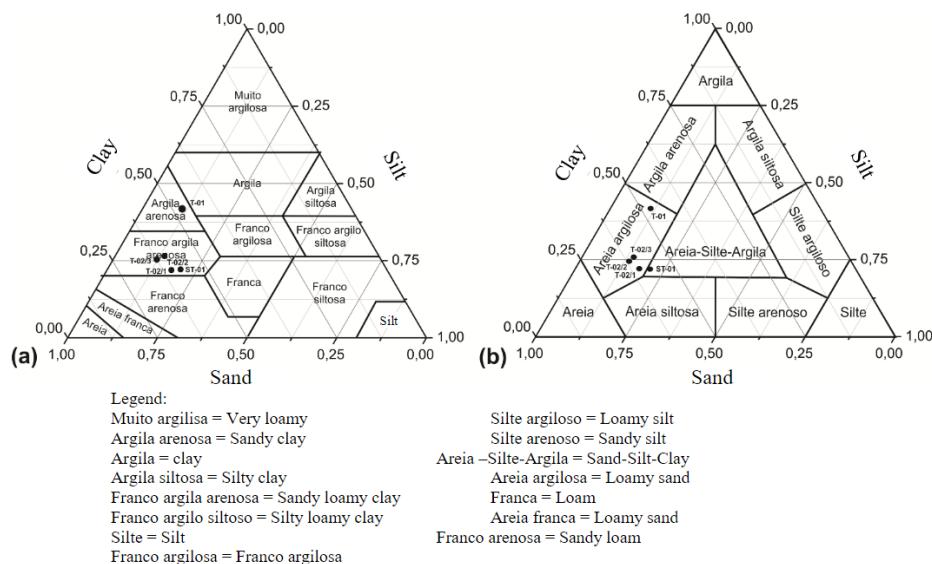
**Figure 5.** (a) The triangular diagram is used for the basic classification of soil textures, Gomes & Silva (1962) [17] for the ST-01, T-01, T-02/1, T-02/2, and T-02/3 samples. (b) The Shepard's [18] classification diagram (1954) is used for the ST-01, T-01, T-02/1, T-02/2, and T-02/3 samples.

The textural analysis (**Figure 5**) indicates samples ST-01, T-02/1, T-02/2, and T-02/3 are classified as Loam Sandy clay soil, and sample T-01 as Sandy clay soil, according to the Gomes and Silva classification (1962). All of the samples were classified as Loamy sand. However, sample ST-01 is situated in the interface between the sand-silt-loam classification by Shepard's classification diagram (1954) [16]. The results contribute to the analyzed and described data in the field.

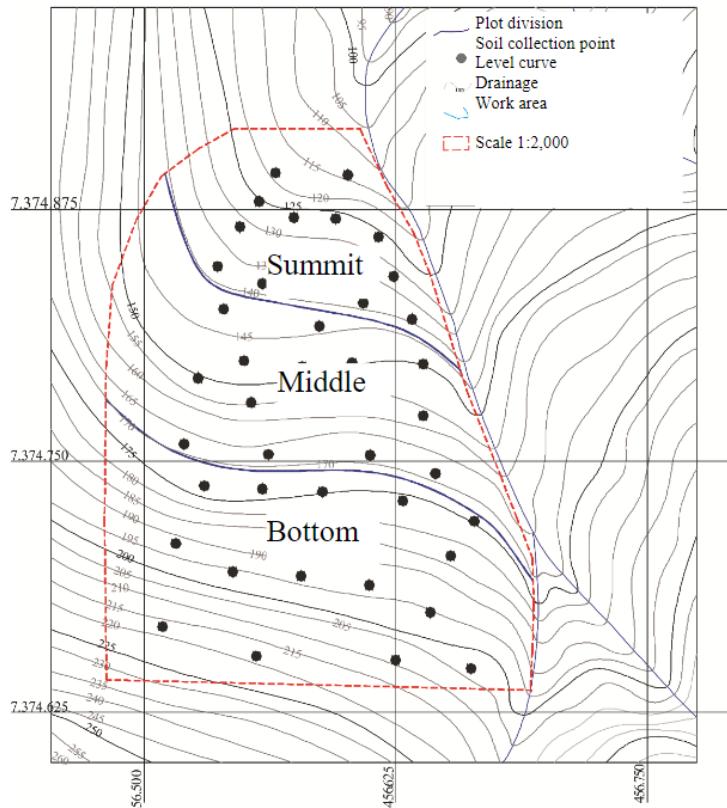
The case study area was divided into three different plots for chemical analysis of the soil (**Figure 6**): (1) The summit refers to the highest part of the case study area. In this location, the soil is covered by grassy plants, such as molasses grass and some very sparse bushes. There is also native vegetation nearby, darker soil is noted due to the deposition of organic matter arising from the native brush; (2) The middle slope is between the highest part and the lower part of the case study area. The vegetation is made up by grassy plants and also a few bushes, the soil is apparently a little lighter than the summit, probably because the area is a little more deforested and far away from the native brush; (3) The base is the lower part of the case study area. The soil coverage is made up of grassy plants. However there are some places where the soil is exposed and lighter than the other plots. As it is an area where there are accentuated declivities and little vegetable coverage, matter can be moved due to bad weather conditions and erosion.
